NATIONAL ELEVATOR INDUSTRY, INC.

**2.7.5.1 Working Areas in the Car or on the Car Top.**

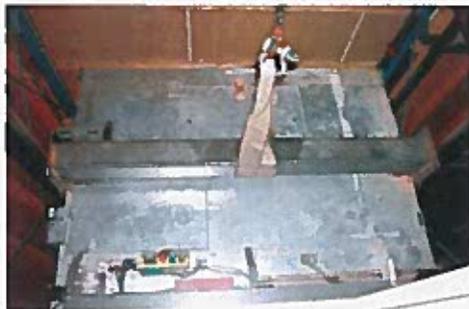
Photo of typical restraint of the elevator car for major repairs / replacements of components such as the car suspension, machine and emergency brakes, motor, and motor controller when located in the hoistway.
